December 21, 2022

RE: **Gross Science Building**  
**Statement of Findings and Conditions**

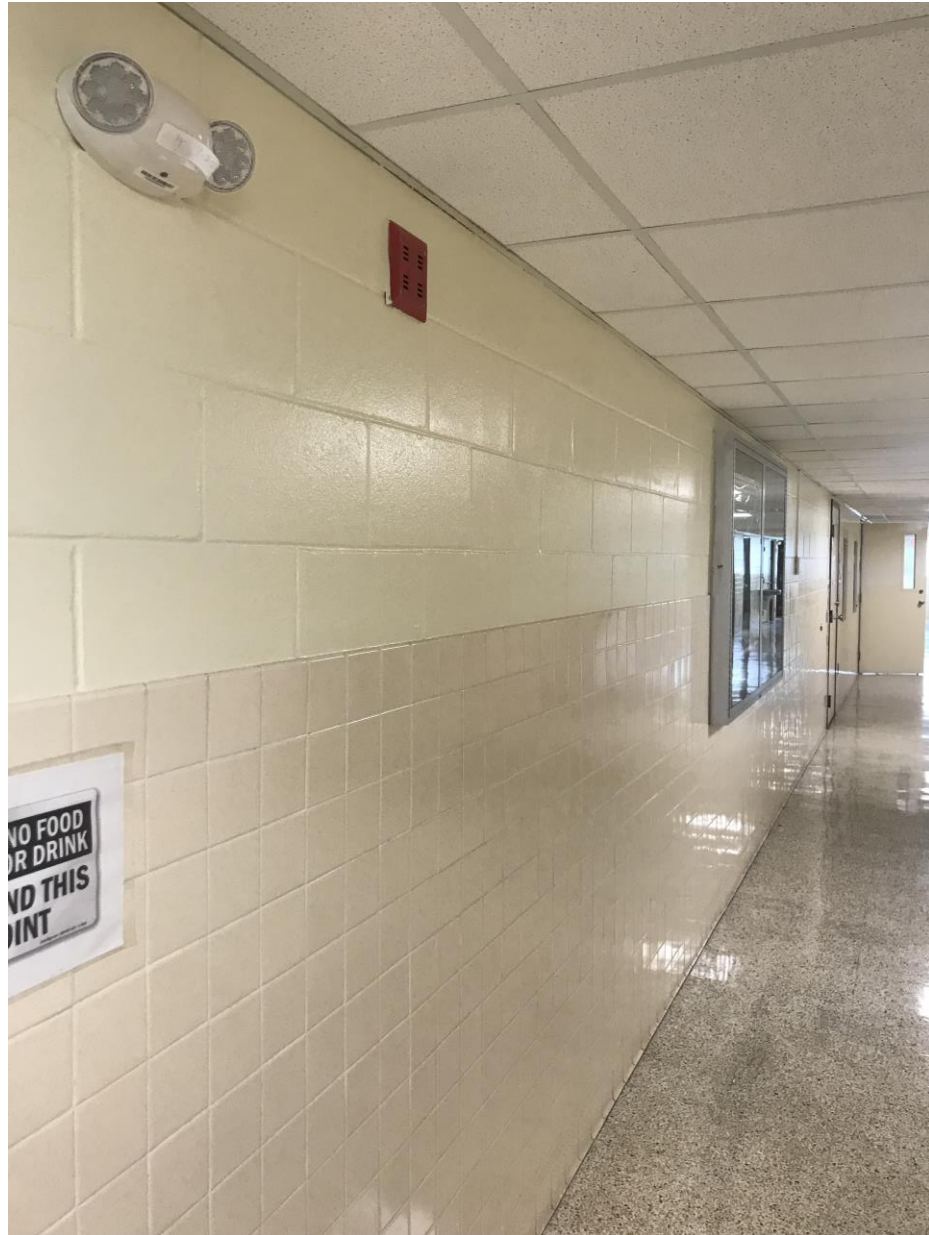
The HVAC systems have been replaced incrementally through the years and have various ages for different areas of the building. The building's HVAC system is run off the chiller at the Central Energy Plant. (Teco Plant). Most of the chilled water air handlers have been changed out by Trane within the past 8yrs, but there are two older air handlers that still run off of old pneumatic controls. These units are presently being run in a manual "Hand" operations and are not fully automated as a result. The resultant tactile condition inside of the building is that an occupant can walk between zones of cooling and sensibly feel the difference in temperature and humidity.

Complete engineering of spaces, uses, needs, and program and complete replacement of all chilled water air handling units as well as all controls, ductwork and air terminals.

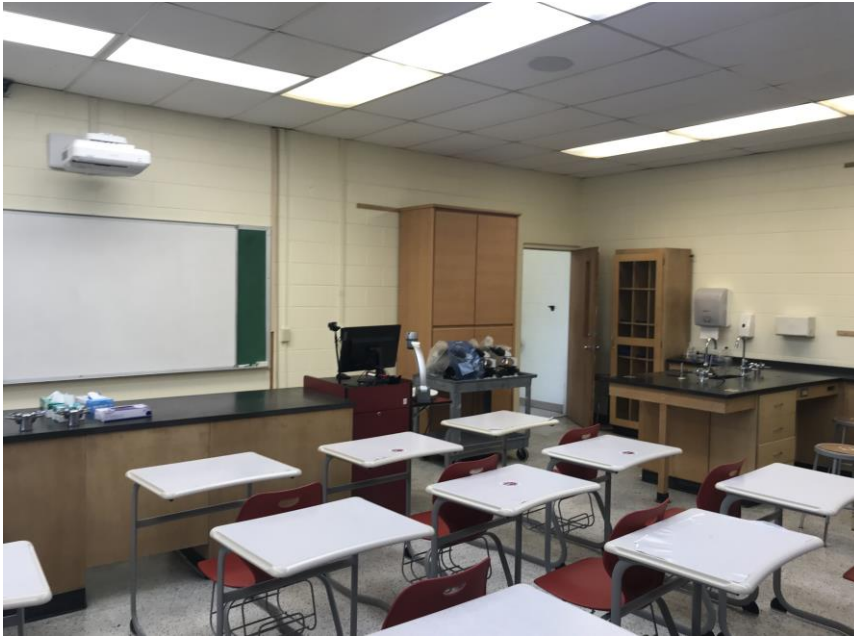
The existing classroom spaces are typical for 1950's construction with renovation throughout the years. There is little built in furniture and desk units are treated as mobile furniture and not permanent work station layout. There is little technology in classrooms other than typical high school style Smart

Boards and typical wireless access point wireless for student use. The finishes are dated, old and worn. VCT floors throughout look to be 12 x 12 recent renovation work. Painted walls are typical, and the acoustical ceilings have a mix of 2x2 and 2x4 grid patterns and an assortment of different acoustical tiles. The light is old T8 florescent bulb fixtures with no special task lighting or dimming capability. In general, the teaching spaces are outdated and in need of complete replacement

These teaching and classroom spaces should be evaluated for average class capacity and size requirements and then re-planned and repurposed to best fit the curriculum and departmental needs. Complete finish replacement and all new updated mechanical, electrical and life safety systems should be added and addressed at the same time.

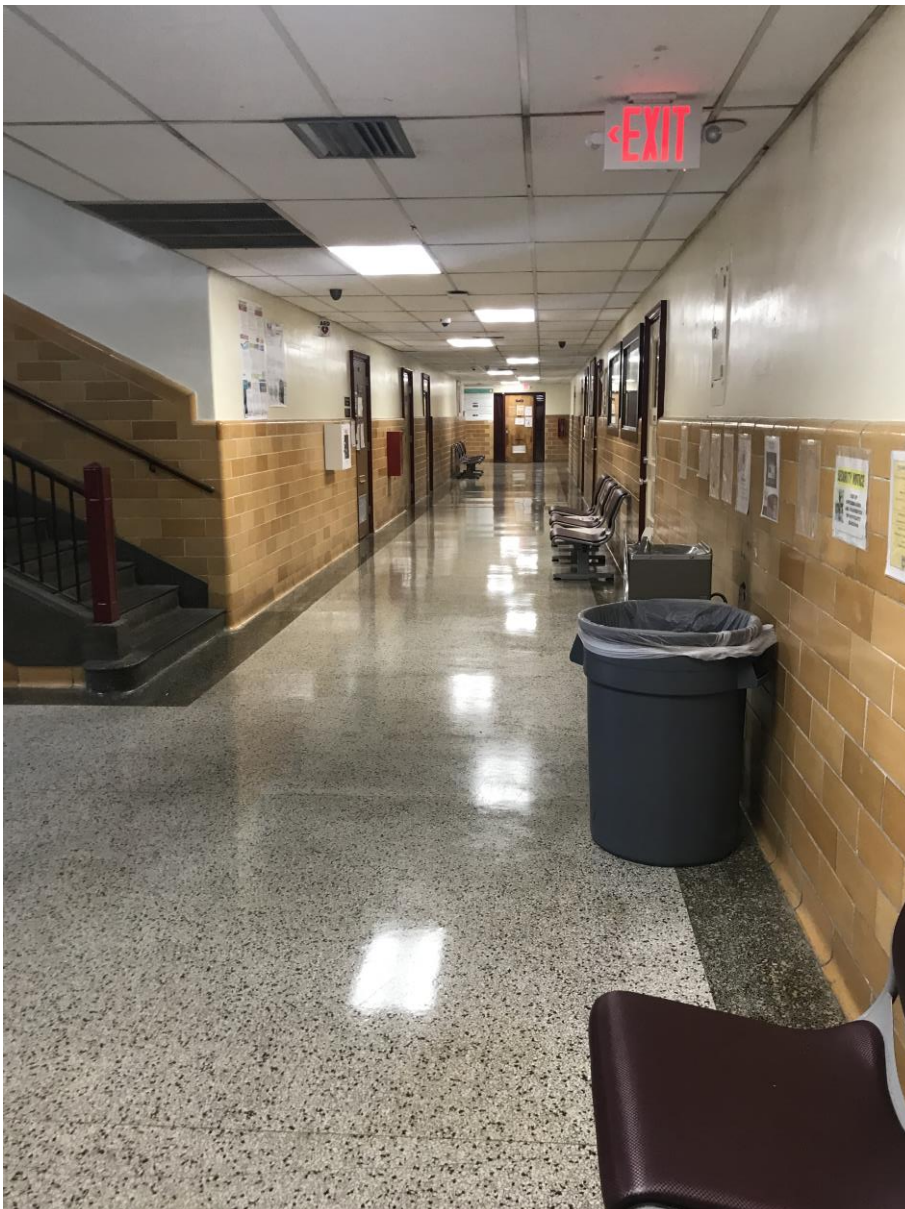
The existing hallways and stairwells and bathrooms are the most original spaces to the building. The hallways have a wainscot height glazed masory tile that is thickset directly to the masonry walls and the floors are the original terrazzo. Although these finishes seem dated, they are probably the most durable aspects of the entire building, and they definitely hold the most interior architectural value of anything in the building. The existing bathrooms do not appear to be ADA compliant and are in need of repair as well.

These finishes need to be discussed for their architectural and historical merit within the institution. If they are to be kept, the floors will need a certified terrazzo specialist to make spot repairs and then clean and re-polish the entire building to remove years of wax buildup, abuse, and neglect. The glazed masonry units on the wall wainscoating are in remarkably good shape and could be kept as-is. The unusual color could be offset by employing an interior designer to make alternate paint and ceiling choices to compliment the earth tones.

The bathrooms need complete fixture replacement as well as new layouts to accommodate ADA and all new ceramic tile walls and floors. New bath accessories with touch free operation should be added simultaneously

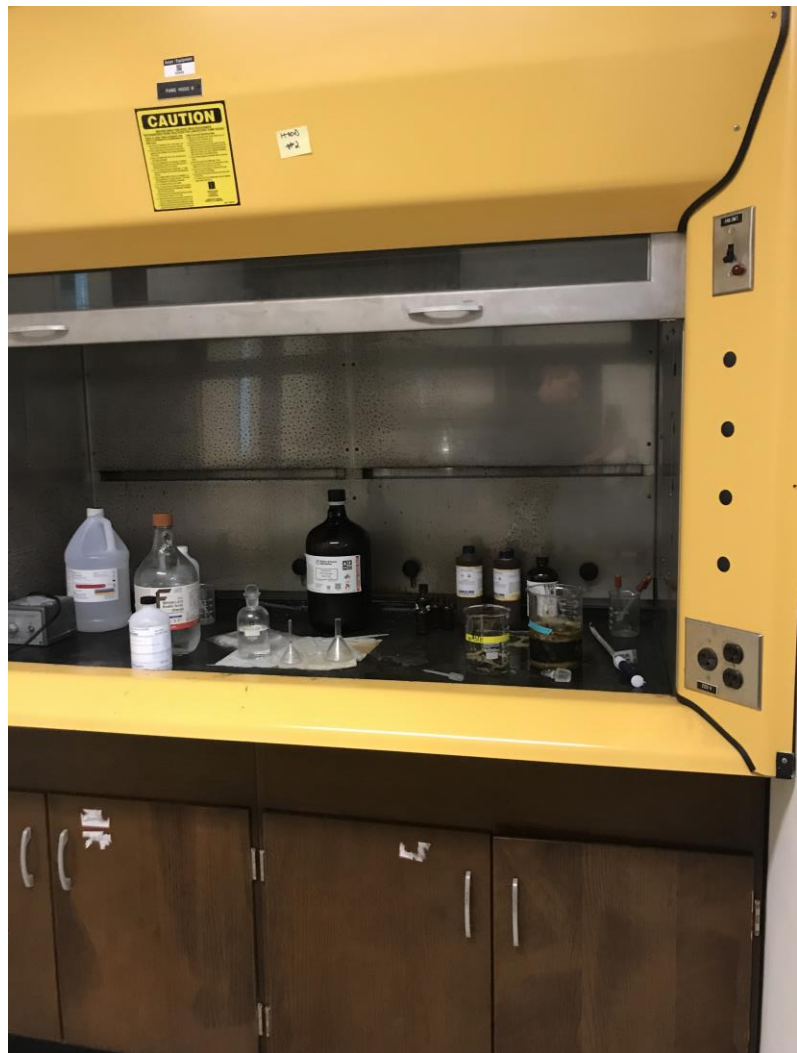
There are several large rooms in the building that serve as primary teaching labs. The largest of these rooms has 12 individual fume hoods as shown below. None of the hoods have been replaced or updated recently and most look to act as storage spaces for chemicals. The laboratory casework is very dated and appears to be stained wood overlay doors and drawers with Trespa chemical resistant black tops. Although they may be functional in their current state, they definitely are not modern design nor are they the colors and materials currently used in the last 20 years either. The mechanical condition of the hoods, their exhaust, the fire protection, the utility services, and any certifications were not examined closely as part of this report.

These teaching and classroom spaces should be evaluated for average class capacity and size requirements and then re-planned and repurposed to best fit the curriculum and departmental needs. Reduction and consolidation of laboratory hoods could serve the space well by concentrating utilities and reducing overall service level. The casework should all be replaced as well and come from the same supplier as the hoods for a complete and streamlined modern lab. Complete replacement of all other associated and all new updated mechanical, electrical and life safety systems should be added and addressed at the same time.

There were other smaller labs throughout the 2<sup>nd</sup> and 3<sup>rd</sup> floors that may have been part of faculty research projects or other smaller lab spaces, but these should be addressed at the same time for consistency
