December 21, 2022

RE: **Gross Science Building**  
**Statement of Findings and Conditions**

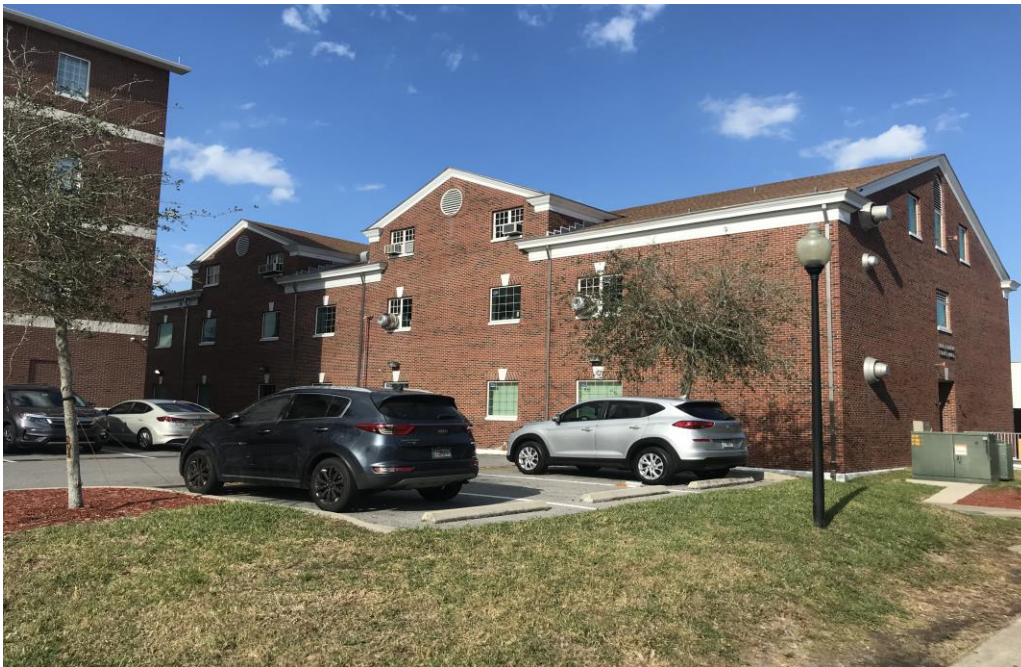
On December 20, 2022, I visited the Gross Science Building on the campus of Bethune Cookman University in Daytona Beach located at 621 Dr. Mary McLeod Bethune Blvd.. The building is a 3 story classroom and laboratory function building that was originally built in 1948 with a traditional central corridor and double-loaded layout and design. The structure is reinforced masonry with brick veneer with a conventionally framed roof structure. Total building square footage is 52,851.
